Solder Alloy Choice for Through Hole Ceramic Discoidal & Planar Array Capacitors

This application note aims to demonstrate the effect the choice of solder alloy has when soldering to the internal bore of these through hole capacitors.

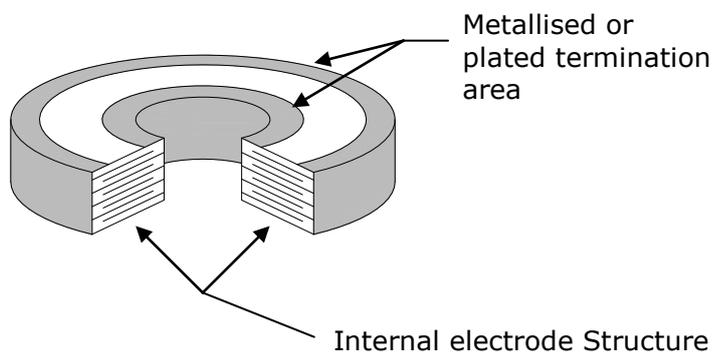
Fig 1
Typical Discoidal
Construction

Through hole ceramic capacitors are based on the technology of multi layer chip capacitors (MLCC's) with modified internal architecture. The manufacture is similar to MLCC's in that layers of ceramic dielectric material interlaced with precious metal electrodes are built up to form the structure, but holes are then drilled in the ceramic to form contacts to the inner or hot electrodes. The outside is machined to shape and makes contact to the outer or cold electrodes. The capacitance is formed between the hole and the outside edge. In the case of planar arrays, capacitance is formed between each hole and the outside edge. Within limits, each hole can have different capacitance characteristics.

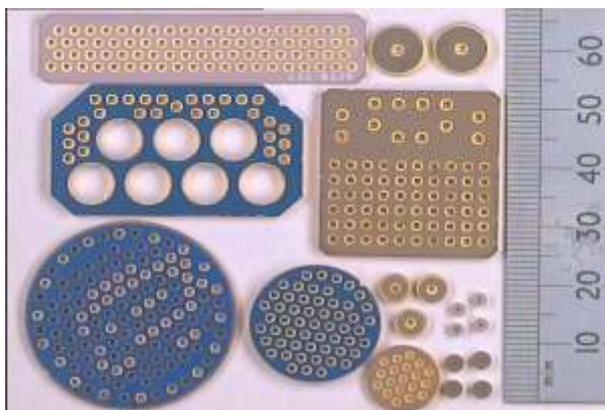
Fig 2
Examples of Discoidal and
Planar Array Capacitors

Single hole devices are usually referred to as discs (they are not necessarily circular) whilst multi hole devices are referred to as planar arrays.

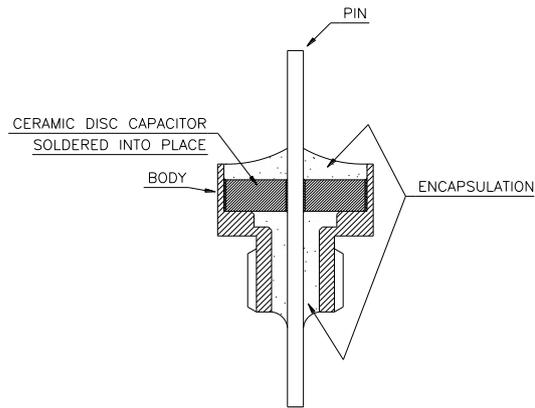
Fig 3
Typical EMI Filter
Construction

The finished capacitor device is used in the assembly of EMI filters and filter assemblies. Their special construction allows the devices to have superior high frequency performance to SM chip based filtering – important for applications such as military, aeronautical and medical. For the construction of an EMI filter, the discoidal or array is soldered into a carrying can, or body, with a pin soldered through the centre. The assembly can then be encapsulated to give improved mechanical and environmental protection. The signal to be filtered is passed through the pin and the outside of the body connected to earth.

The pin and body are usually manufactured from Cu or Cu based alloys, plated with Ag or Au.

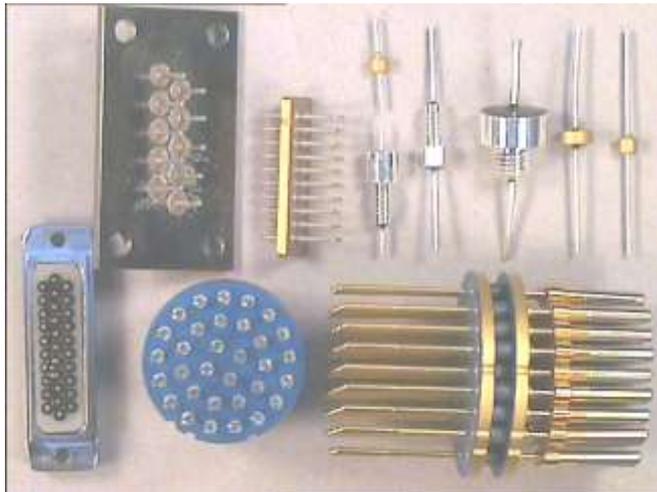
Fig 4
Examples of EMI Filters and
Assemblies

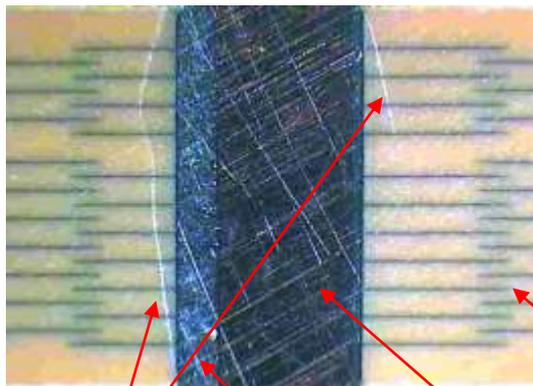
Fig 5

'Longbow Crack'

Capacitor soldered using inappropriate solder alloy. Crack in dielectric material generated during cooling of solder joint after reflow.

It has been acknowledged for some years that soldering to the internal bore of the capacitor had the potential to induce cracks within the ceramic structure. The cracks generated by this process are known as 'Longbow' or 'Comma' cracks from their distinctive shape when viewed from a side cross section or top cross section respectively.

These cracks can be benign or can cause total electrical failure, dependant on whether they pass through the area of electrode overlap. Possibly of more concern, the cracks can be instigated during soldering, but only propagate during further processing or in use, whereupon the capacitor can fail in operation.

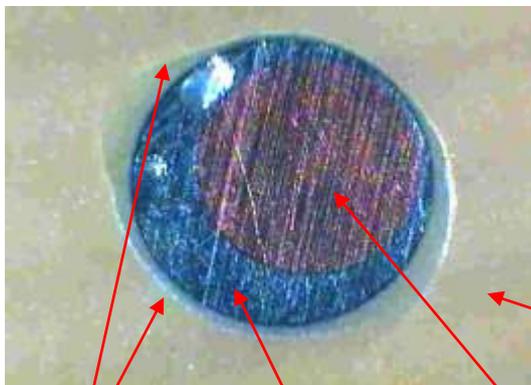
Fig 6

'Comma Crack'

The same crack as in Fig 3 above, but sectioned through a plane 90° displaced.

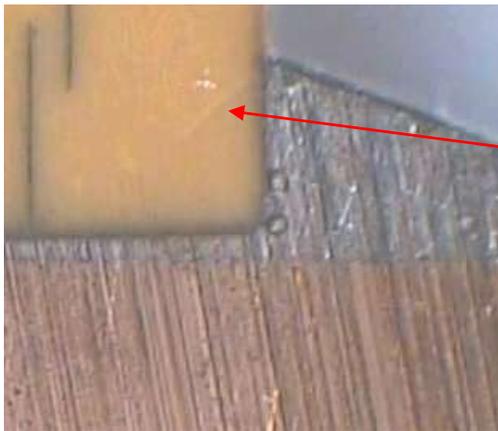
Fig 7

'Corner Crack'

Crack generated by lifting of the pad due to the solder meniscus

A further form of crack commonly found in through hole ceramic capacitors is the corner crack. This occurs when the solder fillet on the surface pad shrinks causing the ceramic to crack and lift. It can be likened to the effect of pad lift on a circuit board.

Corner cracking is less critical than longbow / comma cracking and rarely threatens immediate outright dielectric failure, although the induced crack can propagate in operation causing failures. It can be eased by limiting the volume of solder in the meniscus or reducing the pad size. On very small size parts, it is common to remove the pad entirely.

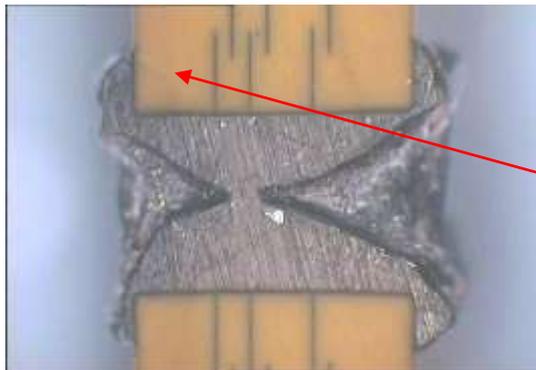
Fig 8

Example of solder joint from which pin has been removed before solder has solidified

Note small corner crack caused by solder meniscus

Investigation into causes of the cracks centred on the solder profile. In particular, it was felt important to understand whether the crack occurred during the heating or cooling portion of the solder profile. To this aim, an array was assembled using 62Sn/36Pb/2Ag solder and the solder was reflowed using a five zone hot air reflow furnace. As the array passed out of the final soldering zone, a number of pins were removed. After cleaning and drying, the array was sectioned and the internal structure analysed – cracks were found in the structure around holes with pins still in place. Where the pins had been removed no longbow cracks were present.

This showed that the cracks only occur during the cooling portion of the soldering profile, and that pins must be present to generate the forces that form the longbow crack. This shows that the forces exerted on the ceramic are external to the capacitor.

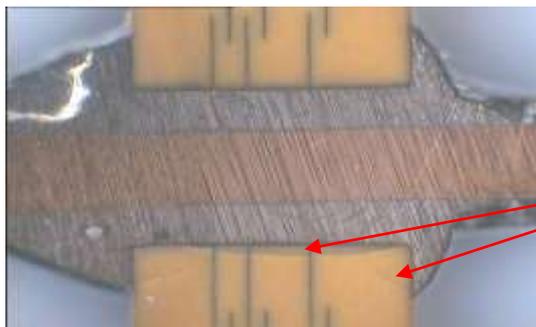
Fig 9

Example of solder joint with pin in place

Note longbow crack and corner cracks

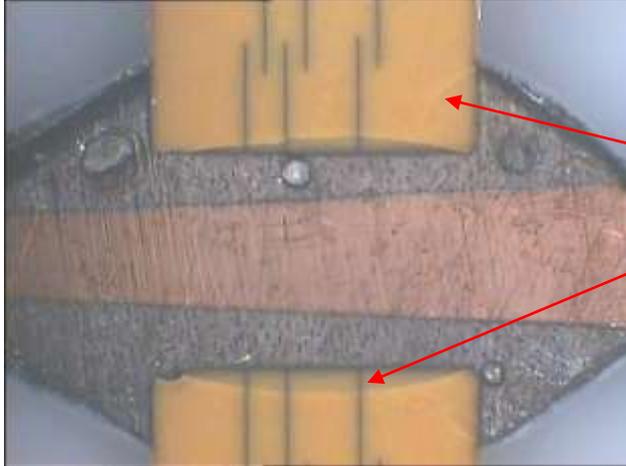
Fig 10

80% of the joints sectioned had longbow cracks adjacent to the solder joint. All the joints inspected had some cracking present in the ceramic, mostly corner cracks..

Example of force cooled
62Sn/36Pb/2Ag solder joint
showing longbow and corner
cracks

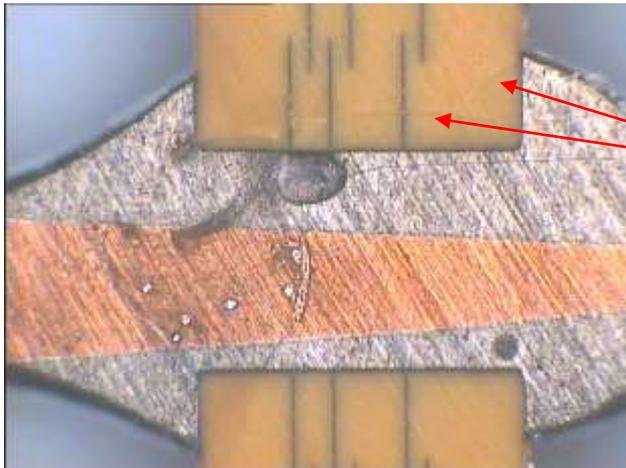
Fig 11

20% of the joints sectioned had longbow cracks adjacent to the solder joint. A total of 60% of joints had corner cracks associated with the solder meniscus.

Example of 62Sn/36Pb/2Ag
solder joint showing
longbow and corner cracks

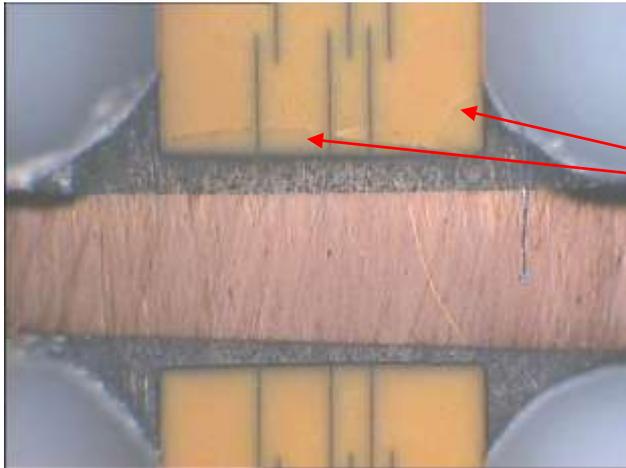
Fig 12

All of the joints sectioned had longbow cracks adjacent to the solder joint. All joints also has corner cracks.

Example of force cooled 60Sn/40Pb solder joint showing longbow and corner cracks

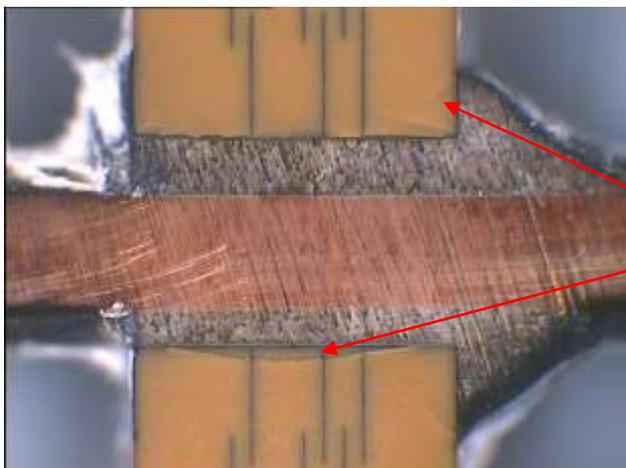
Fig 13

60% of the joints sectioned exhibited longbow cracks adjacent to the solder joint. A total of 80% of joints had corner cracks associated with the solder meniscus.

Example of 60Sn/40Pb solder joint showing longbow and corner cracks

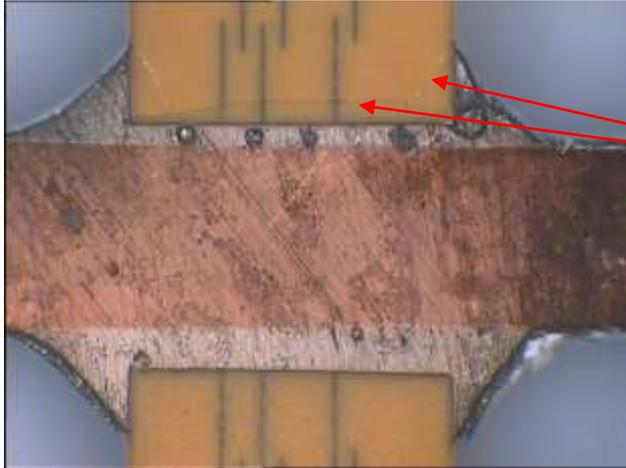
Fig 14

All of the joints sectioned had longbow cracks adjacent to the solder joint. All joints also has corner cracks.

Example of force cooled 99.3Sn/0.7Cu solder joint showing longbow and corner cracks

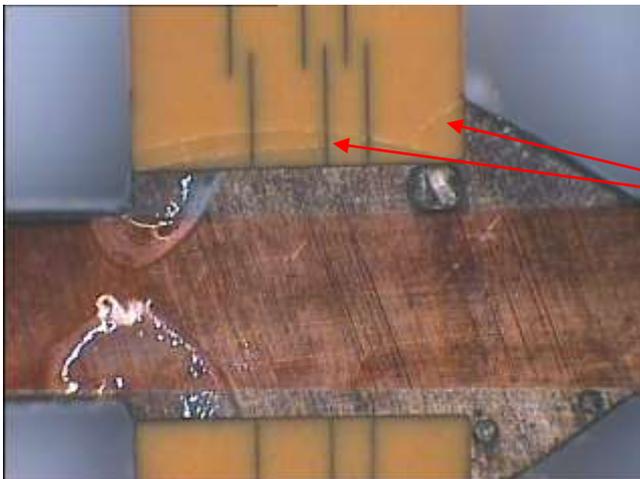
Fig 15

All of the joints sectioned had longbow cracks adjacent to the solder joint. All joints also has corner cracks.

Example of 99.3Sn/0.7Cu solder joint showing longbow and corner cracks

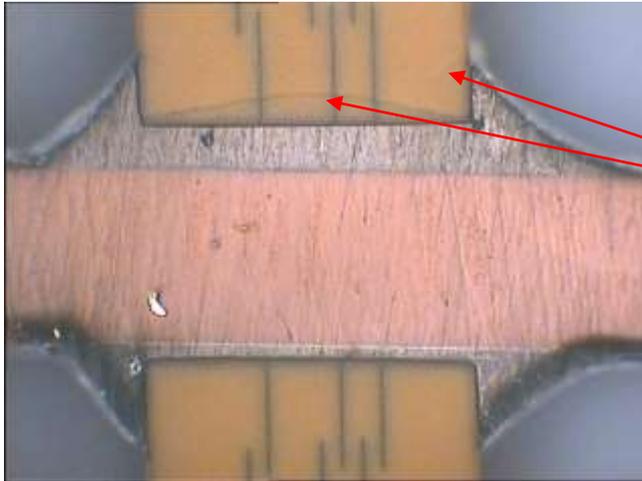
Fig 16

All of the joints sectioned had longbow cracks adjacent to the solder joint. All joints also has corner cracks.

Example of force cooled
95.5Sn/3.8Ag/0.7Cu solder
joint showing longbow and
corner cracks

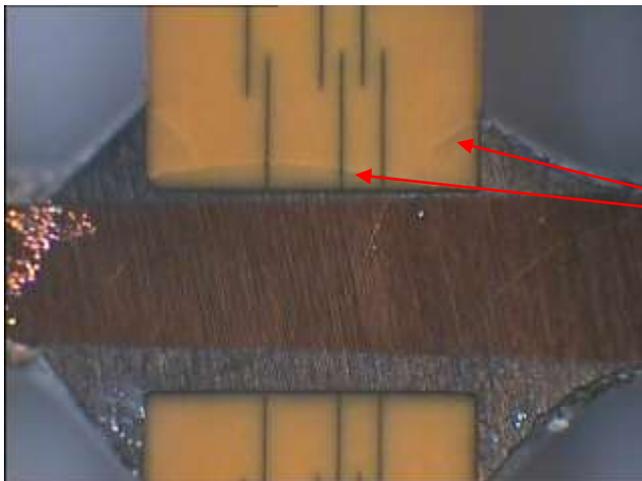
Fig 17

40% of the joints sectioned had longbow cracks adjacent to the solder joint. 80% of the joints in total had corner cracks, mainly corner cracks associated with solder pads.

Example of 95.5Sn/3.8Ag/0.7Cu
solder joint showing longbow and
corner cracks

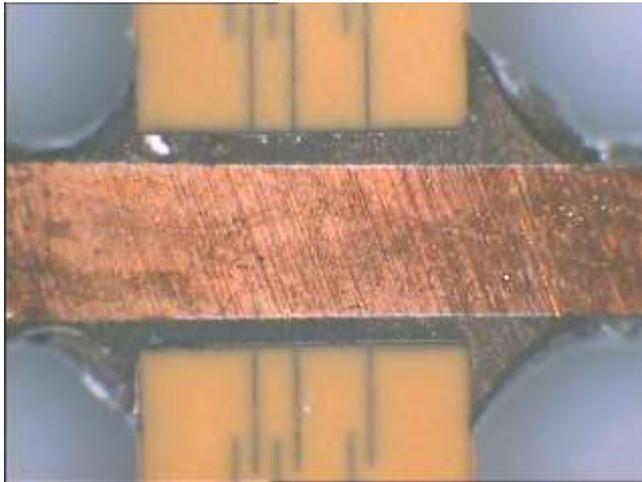
Fig 18

None of the joints sectioned exhibited any sign of induced cracks in the ceramic.

Example of force cooled
50Pb/50In solder joint
showing absence of any
cracks

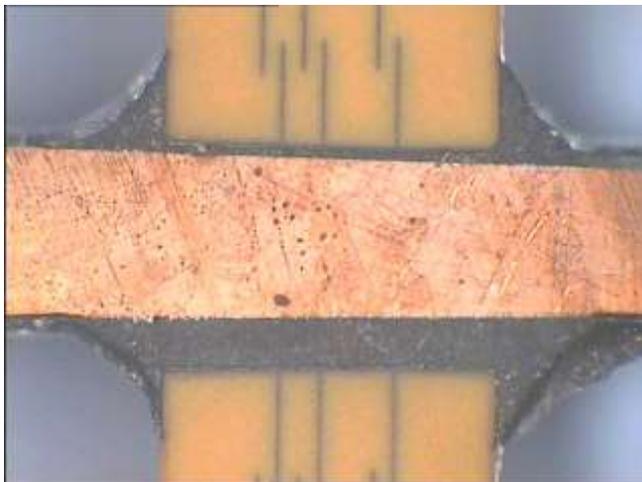
Fig 19

None of the joints sectioned exhibited any sign of induced cracks in the ceramic.

Example of 50Pb/50In solder
joint showing absence of any
cracks

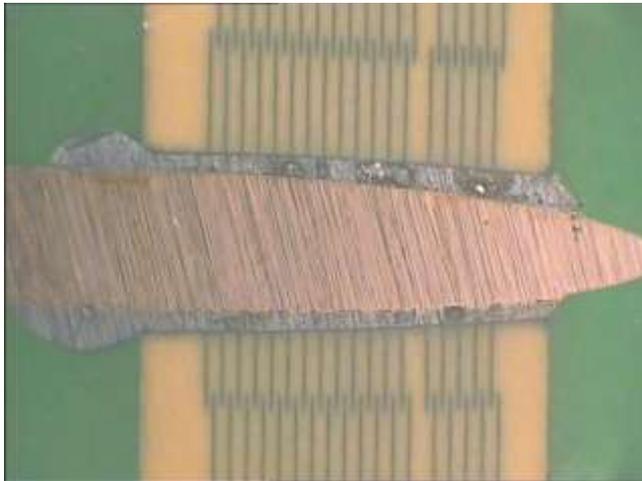
Fig 20

None of the joints sectioned exhibited any sign of induced cracks in the ceramic.

Example of force cooled
95Pb/5In solder joint showing
absence of any cracks

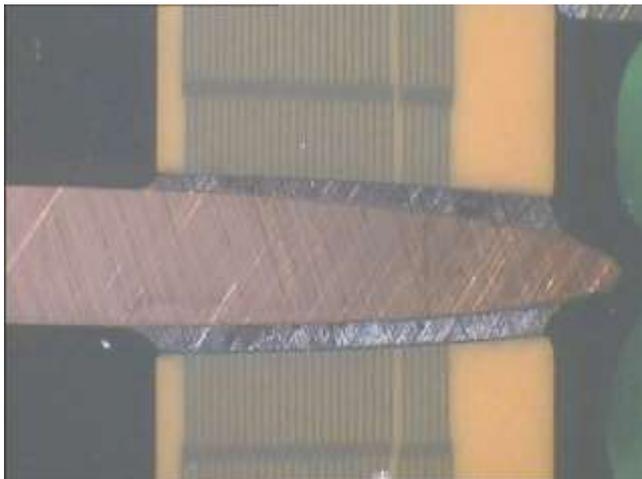
Fig 21

None of the joints sectioned exhibited any sign of induced cracks in the ceramic.

Example of 95Pb/5In solder
joint showing absence of any
cracks

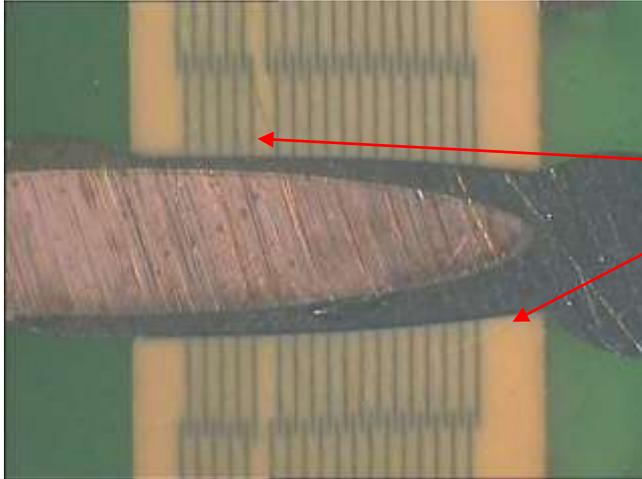
Fig 22

10% of the joints inspected showed very small longbow cracks adjacent to the solder joint. These were noticeably smaller than the cracks seen in other samples.

Example of 93.5Pb/5Sn/1.5Ag solder joint showing small longbow cracks.

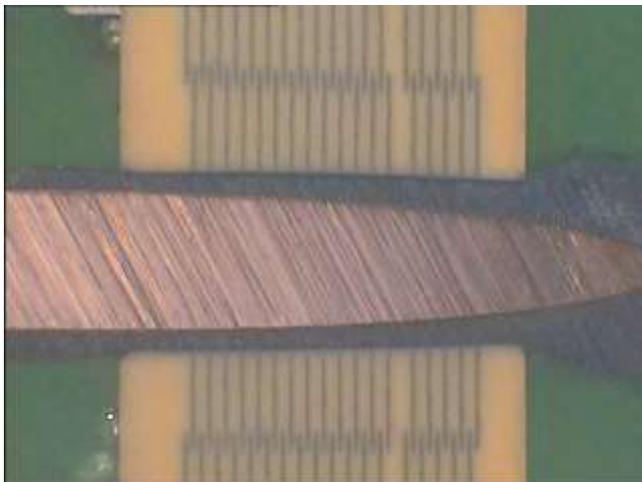
Fig 23

None of the joints sectioned exhibited any sign of induced cracks in the ceramic.

Example of 93.5Pb/5Sn/1.5Ag solder joint showing absence of any cracks

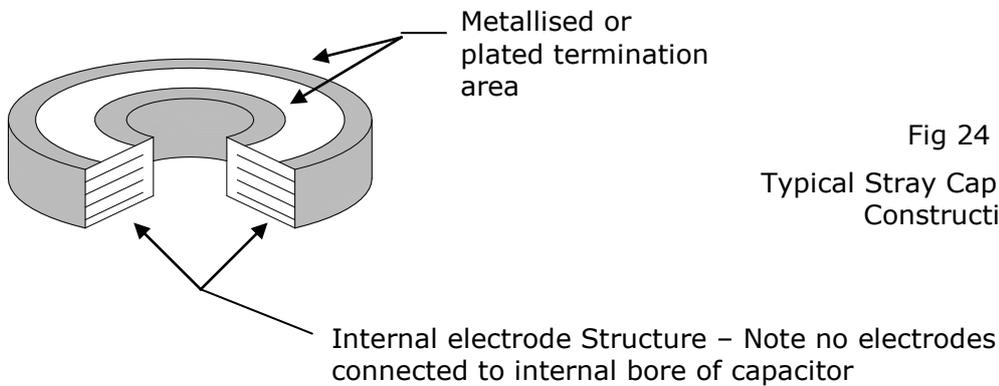
Fig 24
 Typical Stray Cap. Discoidal
 Construction

The capacitance is created by the interaction of the internal bore termination and the outer earth electrodes.

The advantage of carrying out experiments with this type of construction is that any failure of the internal termination or ceramic cracking is demonstrated by a drop in the capacitance. This is because of the introduction of an alternative dielectric material – air – in the area of the failure.

Tests were carried out using capacitor arrays with the electrical design shown above and terminated with PdAg termination material. Prior to assembly, the capacitance of the holes with this design was recorded. The assembly was soldered using 95.5Sn/3.8Ag/0.7Cu solder and hot air reflow. After assembly, the capacitance was re-measured and the results tabulated below.

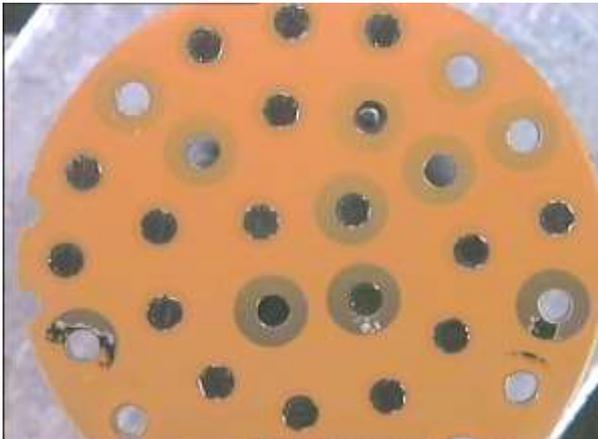
Fig 25

Surface Section of Array No. 2
showing absence of damage to
ceramic

Surface sectioning of both arrays found no ceramic cracks.

One effect that can be seen from the surface sections above is that of solder / termination pull – away from the bore of the ceramic. This has the same effect as the cracks in gold plated parts, introducing a section of air dielectric within the capacitor build.

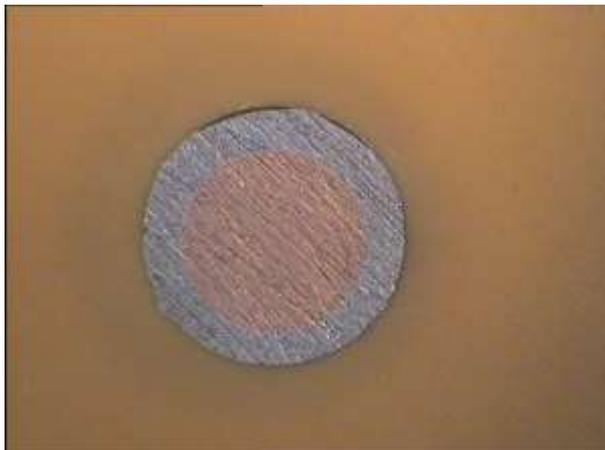
Fig 26

Close-up of Surface Section of Array
No. 1 showing absence of damage to
ceramic

This effect can be seen in FIG 26 above. A further example is below:

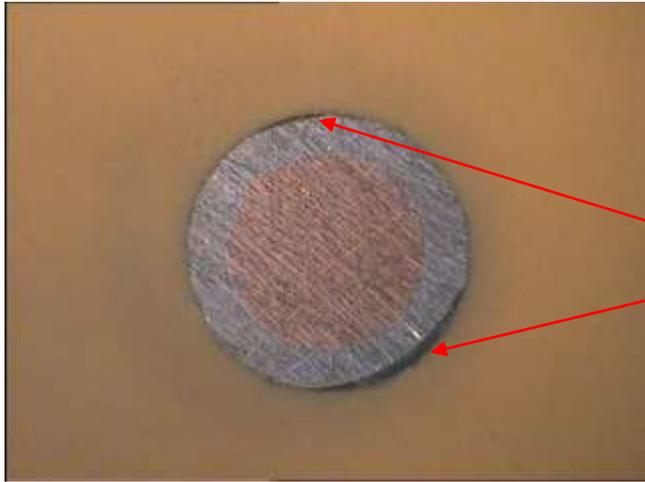
Fig 27

Second Close-up of Surface Section of Array No. 1 showing absence of damage to ceramic, but evidence of pull away of solder / termination from ceramic surface.

It is our conclusion that the unacceptable capacitance drop is caused by the failure of the termination / ceramic bond when exposed to excessive stress force as the solder / pin joint cools.

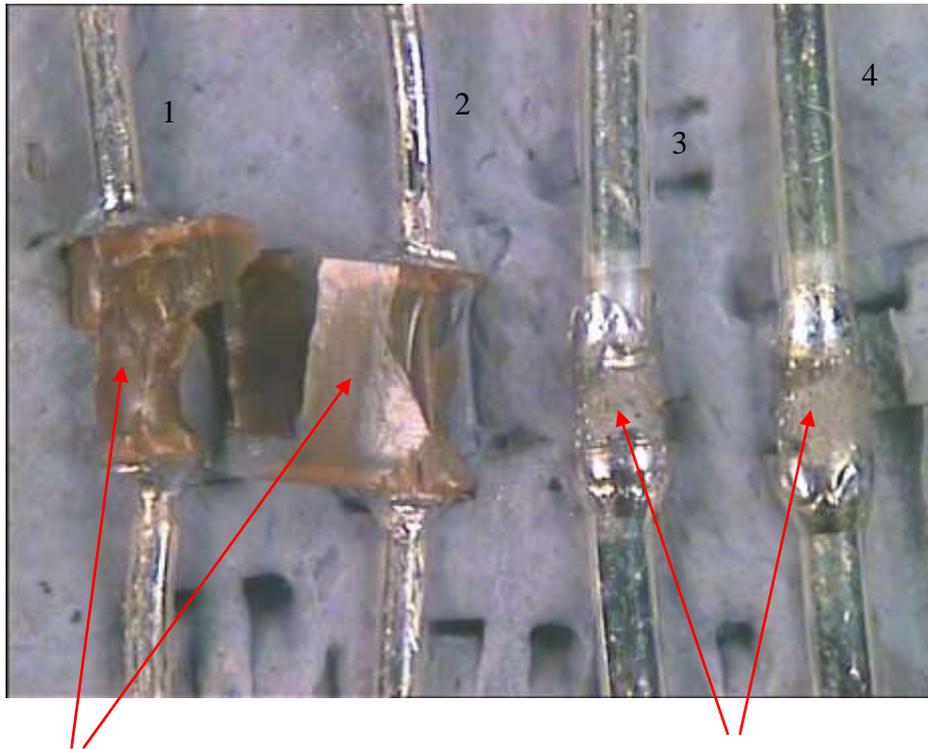
Fig 28

Silver plated copper pins soldered into planar array capacitors using 95.5Sn/3.8Ag/0.7Cu solder and removed by simply pulling out using a pair of pliers.

Pins 1 & 2 have been pulled from an array terminated with gold plate.

Pins 3 & 4 have been pulled from an array terminated with PdAg fritted termination.

Fractured ceramic remaining attached to the feedthrough pin after attempting to pull the pin out.

On closer inspection its possible to see the internal electrode structure of the capacitor.

Both demonstrate the characteristic shape of the longbow / comma crack in the way the ceramic fractured

Remains of PdAg termination can be seen on the otherwise 'clean' solder joint on pins 3 & 4

As can be seen above, the gold plated termination has a far greater adhesion to the ceramic, demonstrated by the amount of ceramic material still attached to the pin. By comparison, the PdAg termination has been cleanly removed from the ceramic with no ceramic material removed. Pins 3 and 4 do show the PdAg termination still attached to the solder – identified by the dull grey areas on the solder.

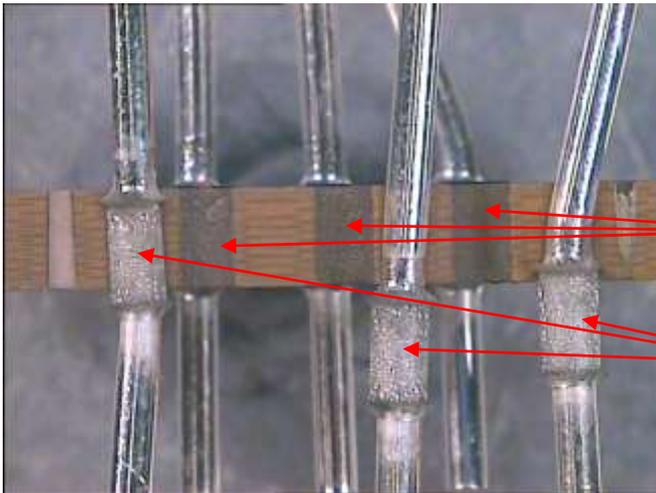
Fig 29

Example of PdAg terminated planar array capacitor soldered with 95.5Sn/3.8Ag/0.7Cu solder.

As the component is sectioned, the pins can be easily removed without damage to the ceramic.

Note the dark grey on the solder joint – this is the termination, which has been removed along with the pin & solder.

The ceramic exhibits no damage, and the pins are very easily removed – the termination has relatively little adhesion to the ceramic.

This is further shown in FIG 29, where the pins have been removed from a partially sectioned array soldered with PdAg termination.

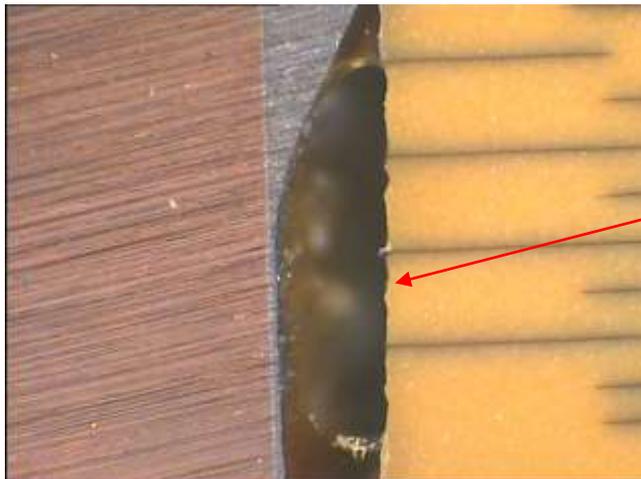
Fig 30

Termination leached away from this area.

These electrodes have lost contact and will result in a potential reduction in filtering performance.

2. Secondly, PdAg termination is far more susceptible to leaching into the molten solder as the joint is formed. In sectioned components, this is observed as areas of missing termination within the bore of the component.

Leaching is far more common with Pb free alloys, and has been observed on PdAg terminated components with all Pb free alloys. The following examples have been soldered using 95.5Sn/3.8Ag/0.7Cu solder alloy.

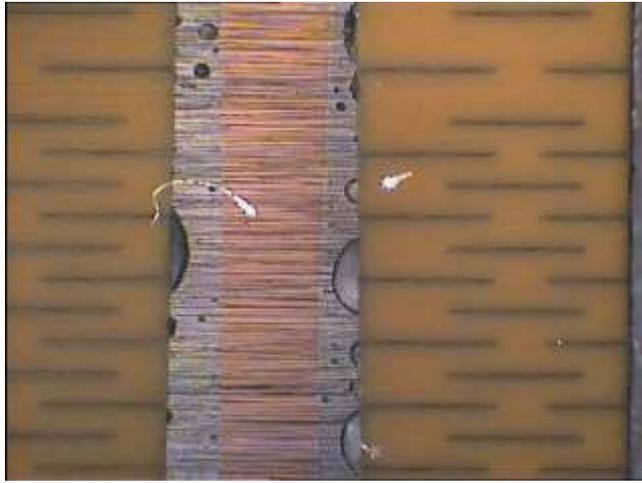
Fig 31

Further example of leaching and poor solder joint with PdAg termination.

This leaching also has the effect of reducing the termination adhesion between the termination and the ceramic.
