# Flexibility of Multilayer Ceramic Capacitors

Automotive grade Multilayer Ceramic Capacitors with Mechanical Crack Resistance.

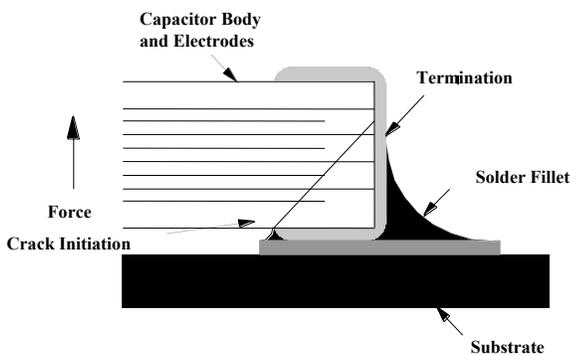
Figure 1: Mechanical crack

Due to its brittle nature of Ceramic, multilayer ceramic capacitors are more prone to excesses of mechanical stress than other components used in surface mounting. One of the most common causes of capacitor failures is directly attributable to bending of the printed circuit board (PCB) after solder attachment. Excessive bending will create mechanical crack(s) within the ceramic capacitor, see Figure 1. Mechanical cracks, depending upon severity, may not cause capacitor failure during the final assembly test. Over time moisture penetration into the crack can cause a reduction in insulation resistance and eventual dielectric breakdown leading to capacitor failure in service.

When mechanical cracking has been identified as the cause for capacitor failures the typical approach for customers is to review the production process for any obvious process stage including handling and transportation that may be bending the PCB. If no obvious stage is identified then the next step is to remove samples of capacitors from assemblies at different process stages and then subject the capacitors to sectioning/ internal examination to determine if the capacitors have been cracked. The shape of mechanical cracks is shown in Figure 1.

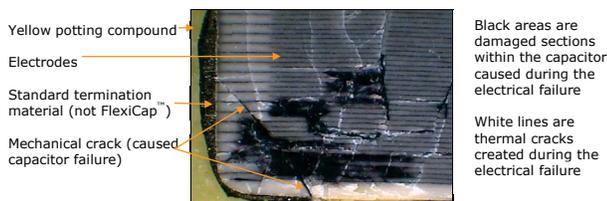
Example of capacitor issued by customers to Knowles

Precision Devices for failure investigation:

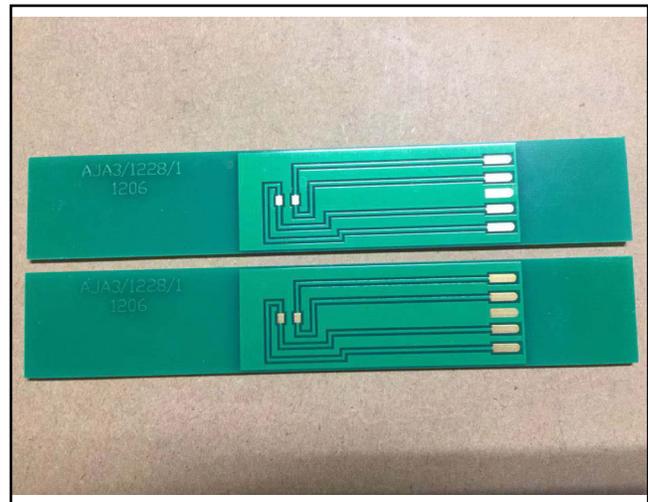
Figure 6: Example of PCB Used

Knowles Precision Devices has designed a series of bend test boards using FR4 materials. The board dimensions are approximately 100 mm x 40 mm x 1.6 mm and the track thickness is 35+/- 10 Microns, see Figure 6.

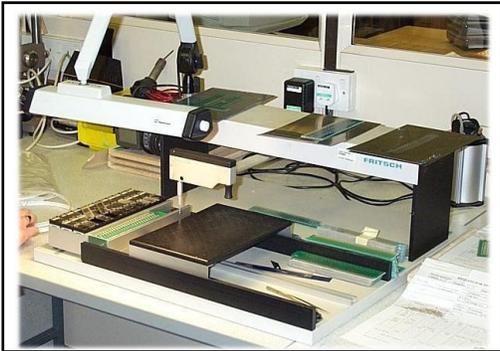
Figure 7: Capacitor placement method

Samples of capacitors are mounted using manual pick and place equipment, see Figure 7, onto

stencilled SAC305 (96.5/3/0.5 Sn/Ag/Cu) solder.

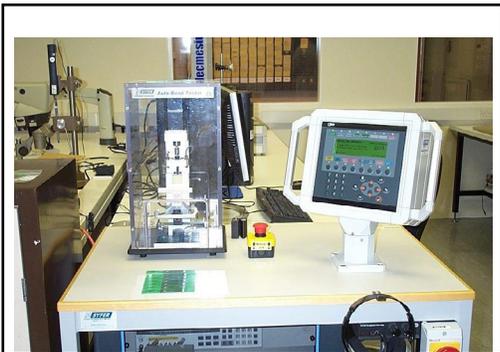
Figure 8: Bend Test Facility

The PCB are then subjected to bend testing in accordance AEC-Q200-005 using Knowles Precision Devices purpose build bend test facility, Figure 8.

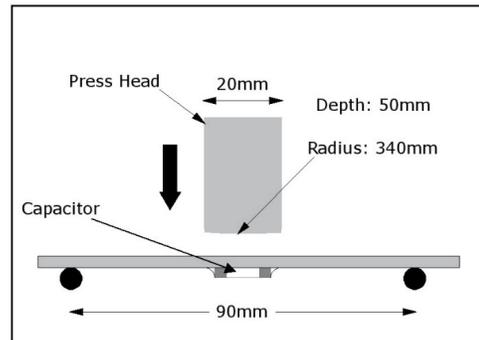
Figure 9: Knowles Precision Devices bend test method

Figure 9 shows the bend test fixture, the hardened steel press head is programmed to follow a deflection profile, with a ramp rate of 1mm/s and dwells in accordance with AEQ-Q200-005

Devices Test PCBs are mounted with one capacitor and deflected automatically until the capacitor breaks. The software analyses the change in capacitance measured by the Agilent 4288A capacitance meter. As soon as the capacitance change is greater than 10% the bend deflection distance is recorded in millimetres. The maximum deflection of the machine is 10mm.

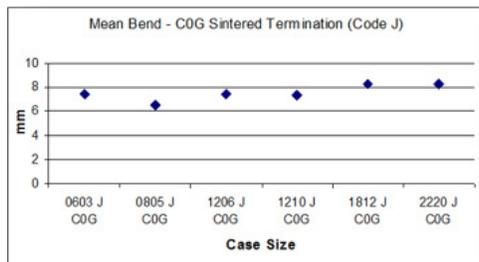
Figure 10: Class I C0G/NP0 with sintered termination

This difference in mechanical strength is shown in the mean bend analysis of the sinter termination for the two class types;

It can be seen that mean bend distance achieved by Class I C0G/NP0 (1B/CG) is typically 7mm while Class II dielectrics have a mean value of typically 4mm.

The dielectric analysis in section 3.1 has shown that Class II X7R (2R1) dielectric materials using sintered termination materials are mechanically weaker when compared to Class I C0G/NP0 (1B/CG) dielectric materials with sintered termination. In fact Class I C0G/NP0 (1B/CG) has close to double the mechanical strength of Class II X7R (2R1), and thus Class II X7R (2R1) would clearly not meet the electronic design engineers demand for increased mechanical crack resistance.

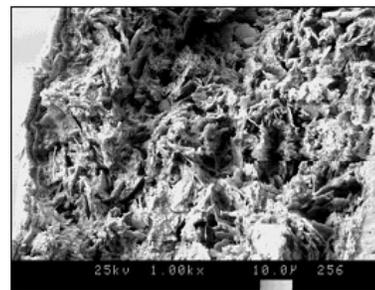
Figure 12: Polymer termination Microstructure

FlexiCap™ polymer termination with its fibrous structure effectively reduces the mechanical stress being exerted onto the ceramic section of the capacitor by approximately 50%, see Figure 12.

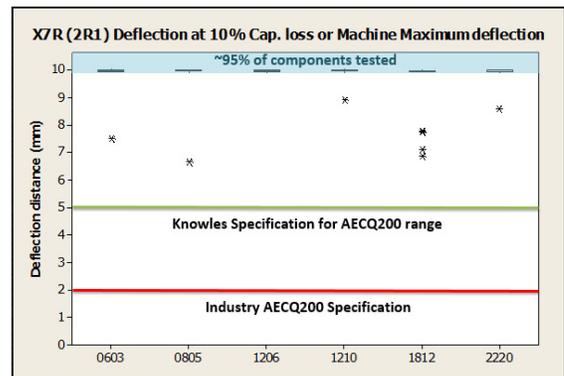
Figure 13: X7R (2R1) with FlexiCap™

The Figure 13 box plot shows the results of subjecting 160 samples of a range of case sizes from all Knowles Precision Devices AEC-Q200

Class II X7R (2R1) materials. It can be seen that the majority of parts, ~95% meet or exceed the bend test machines maximum deflection of 10 mm which typically equates to a weight of 10 Kilograms being placed on the PCB. It should also be noted that all of the remaining ~5% of parts tested exceed the AEC-Q200 specification of 2mm deflection by more than double with the lowest single value measured in this sample group having a deflection of 6.67mm.

The Polymer termination analysis in section 3.2.1 clearly shows that by selecting Knowles Precision Devices FlexiCap™ termination material for Class II X7R (2R1) dielectrics the components resistance to mechanical cracking is significantly enhanced by the absorption of stress in the termination material. Thus by reaching this higher level of mechanical performance Knowles
